Performa 6200/6300 Series

Performa 6200, 6205CD, 6214CD, 6216CD, 6218CD, 6220CD, 6230CD, 6290, 6300CD, 6320, 6320CD, 6360

Repair Overview for Freezing and Video Color Hue Issues

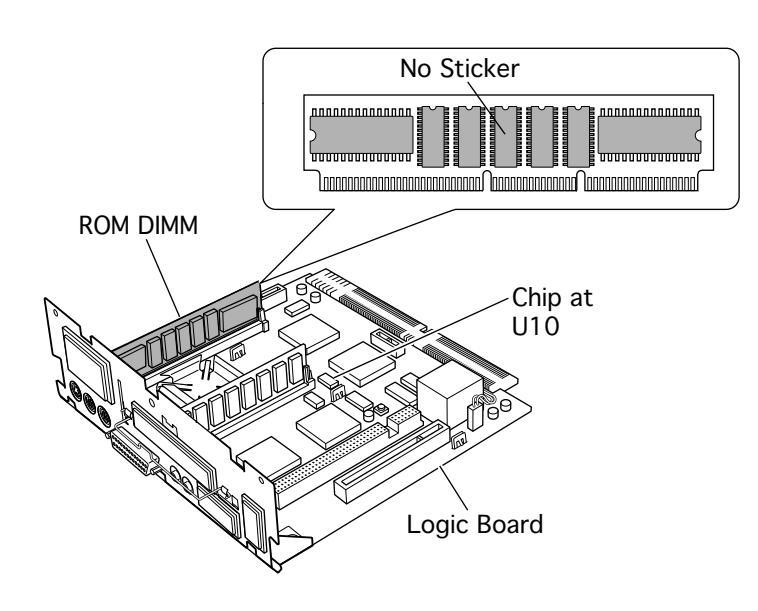
6 Inspect the clock chip at location U10. If it is not printed with part number 343S1191 or 343S1121 (ignore any letters following the part number), replace the logic board. Go to step 14.

> **Note:** The 5XXX/6XXX Tester will report that an issue has been found with the logic board.

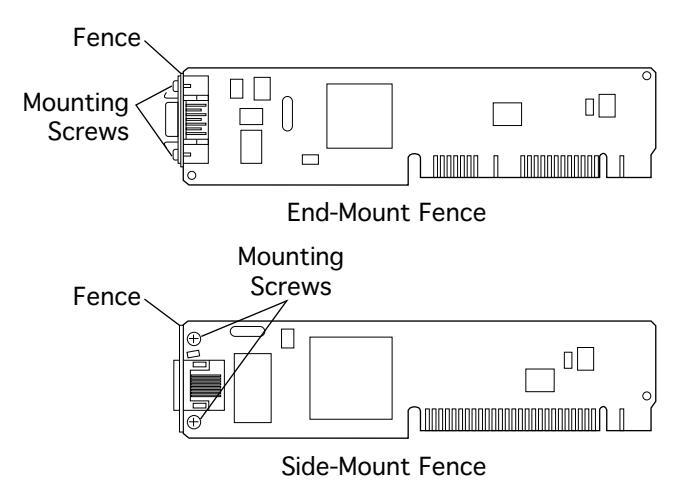
Replace the Ethernet Card Fence

- 25 Inspect the metal fence on the Ethernet card.
- 26 If the card fence hooks onto the logic board fence, **go to step 30**.
- 27 If the card fence does not hook onto the board fence and the card fence is riveted onto the card, replace the card.
- 28 If the card fence does not have a hook and is screwed onto the card:
 - Remove the card.
 - Remove the two card fence screws.
 - Remove the old fence.
