Performa 6200/6300 Series

Performa 6200, 6205CD, 6214CD, 6216CD, 6218CD, 6220CD, 6230CD, 6290, 6300CD, 6320, 6320CD, 6360

Repair Overview for Freezing and Video Color Hue Issues

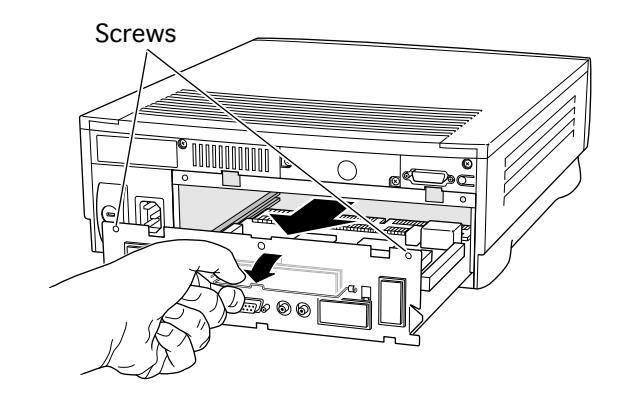
Inspect the Logic Board

6 Inspect the clock chip at location U10. If it is not printed with part number 343S1191 or 343S1121 (ignore any letters following the part number), replace the logic board. Go to step 14.

> **Note:** The 5XXX/6XXX Tester will report that an issue has been found with the logic board.

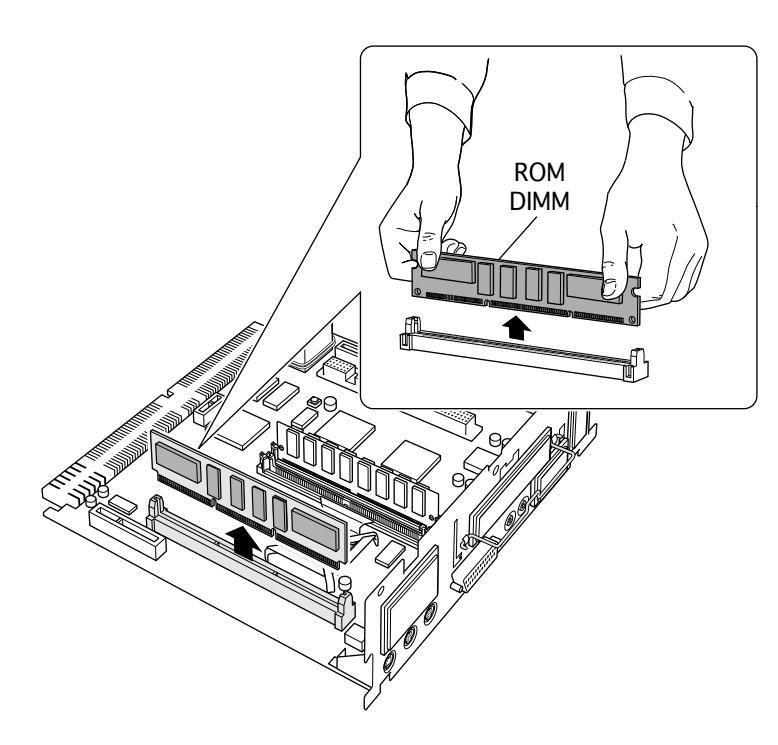
Replace the Cache/ ROM DIMM

Replacing the logic board or Cache/ROM DIMM addresses known component issues that can cause system freezes (the system clock stops and moving the mouse does not move the cursor).

and does not include a sticker on the center chip, replace the DIMM. Otherwise, **go to step 24.**

8 Hold each end of the Cache/ROM DIMM between the thumb and forefinger of each hand.

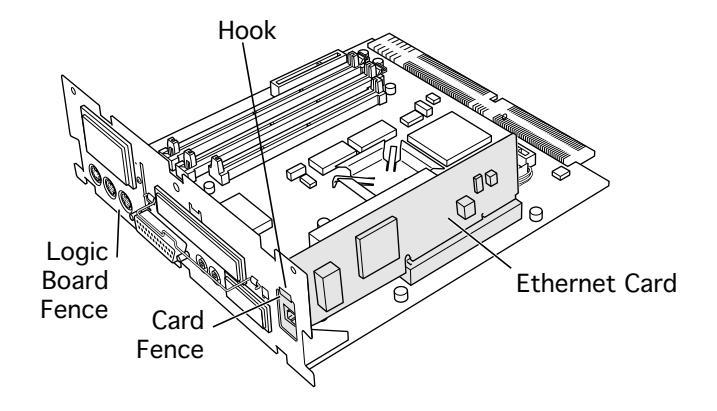
Replace the Ethernet Card Fence

Installing a hooked fence on the Ethernet card provides a way to hold the card more securely in the communications slot. Without the hooked fence, the card could rock out of the slot and cause intermittent network connection.

Perform steps 25-29 if an Apple Ethernet card is installed on the logic board (whether or not you are replacing the logic board).

- 25 Inspect the metal fence on the Ethernet card.
- 26 If the card fence hooks onto the logic board fence, **go to step 30**.
- 27 If the card fence does not hook onto the board fence and the card fence is riveted onto the card, replace the card.
- 28 If the card fence does not have a hook and is screwed onto the card:
 - Remove the card.
 - Remove the two card fence screws.
 - Remove the old fence.

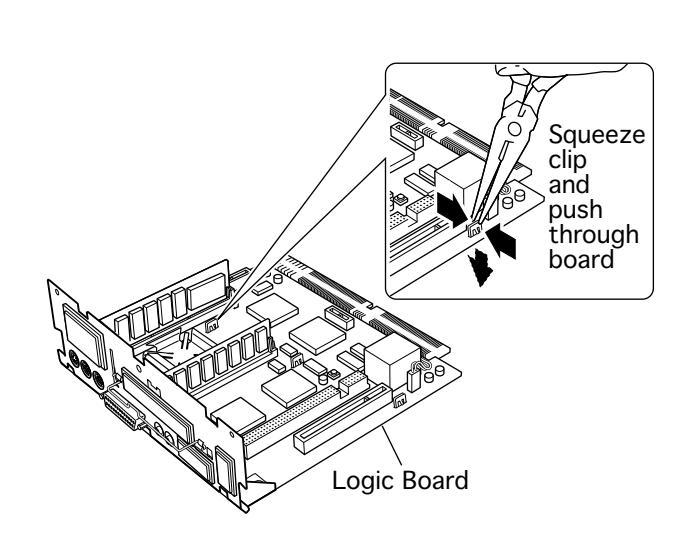
If you are retaining the original logic board, you must replace the board's three EMI clips (ground clips). Perform steps 30-33 only if you are not replacing the board.

30 With the logic board facing right side up, squeeze together the top of each EMI clip and push it out through the slot.
